## Android Auto & Apple CarPlay Software Upgrade - Error Code 106

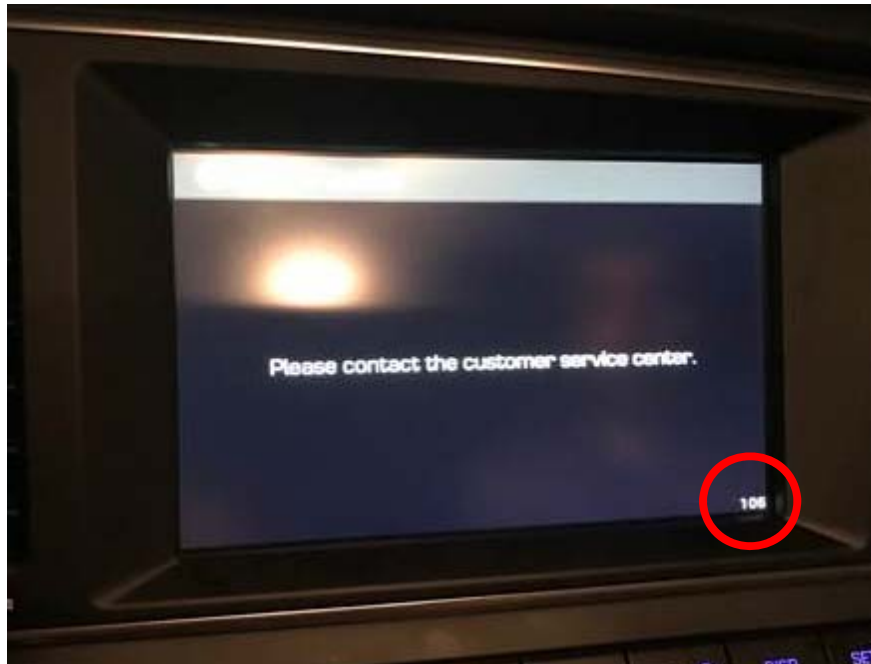
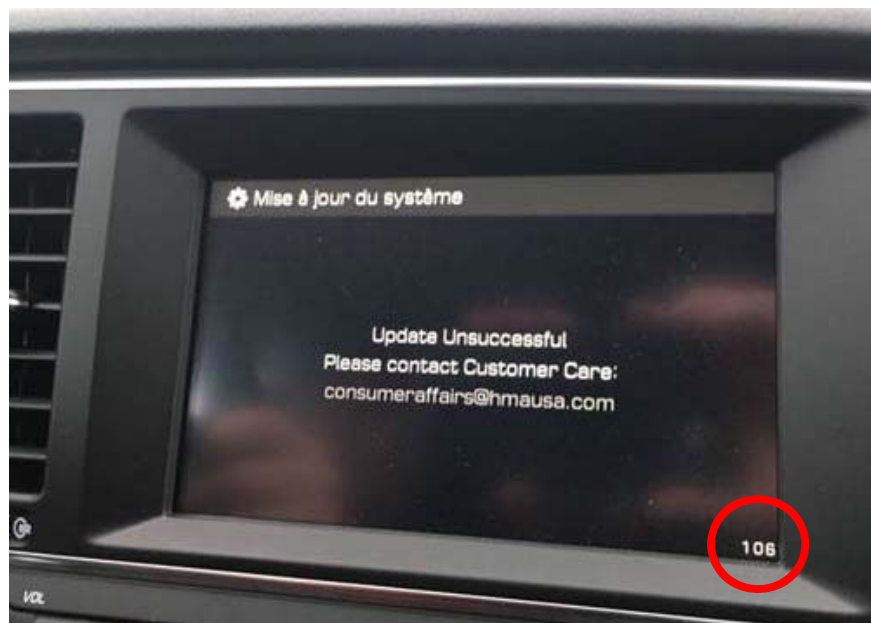
During Android Auto & Apple CarPlay software upgrade, the progress may stop abruptly and the screen only display a black screen with an error message. This error can be recognized by the error code "106" on the bottom right corner of the screen.

Error 106 occurs when the vehicle multimedia system fails to read voice database from USB. There could be two causes for this failure – loading glitch or USB corruption.

### 1. Reset & Retry (for loading glitch case)

Loading glitch can be fixed easily – retry to upgrade.

- First, reset the radio – press and hold the reset button next to the radio power knob (for 2 or more seconds)

If an error code appears, **do not remove the USB or turn off the ignition**. Press the reset button with a thin object to continue the update.

- 
- Restart the upgrade process to install Android Auto & Apple CarPlay software.
- If the same failure occurs, proceed to step 2.

- If number 1 procedure fails again, it means the USB is not compatible with the vehicle system (either it is corrupted or its USB format is not compatible).
- We recommend using a different USB to download the file.
- With the new USB, repeat step 1.
